## **DW1000 Errata**

**Version 1.4**

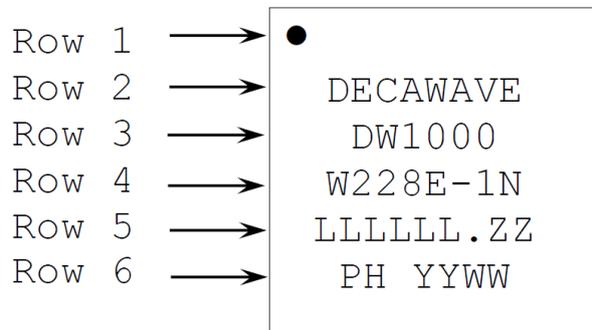
Figure 1 Device Package Markings

\* DW1000 silicon revision identifier. In this example the revision of the IC is "E". **Devices marked with silicon revision identifier prior to 'E' (for example 'C') should not be used for DW1000 designs.**
